# Ossu WASH Assessment

## Preliminary Investigation and Options Report

July 2016

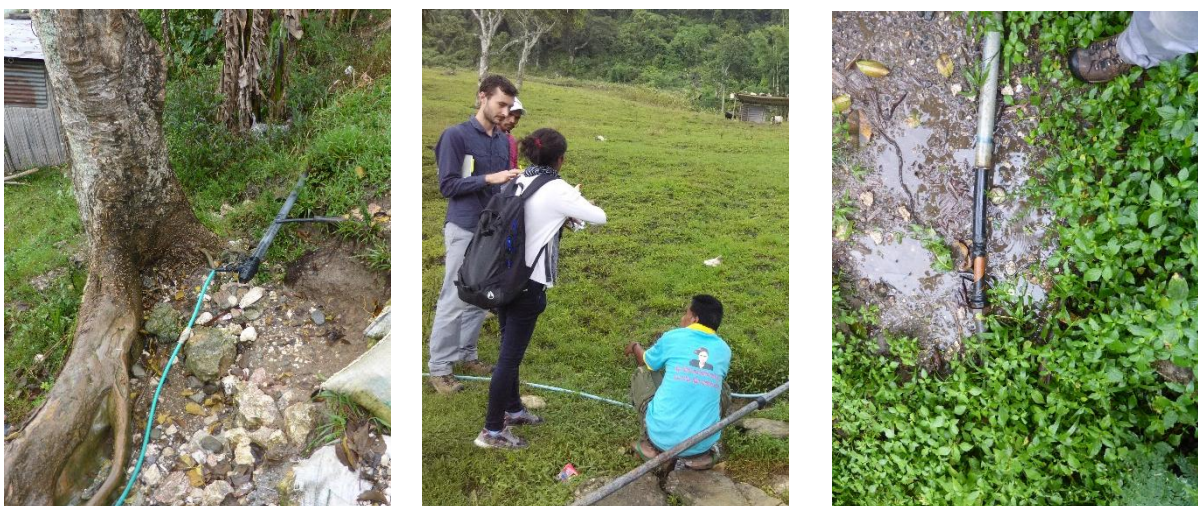
WaterAid observed, and it was widely acknowledged, that many households make informal connections (by cutting or drilling into the pipes) to supply water for their households and livestock. These also provide locations for water loss through leakage. The extent of informal household connections has occurred, at least in part, due to lack of clear management structures for the systems. These connections mean that while houses at the upstream end of the system probably draw sufficient water for household and agricultural use, the volume of water reaching houses at the downstream end of the system is insufficient, especially in the dry season.

Figure 1 – Examples of community informal connections to the Uaiquirona system

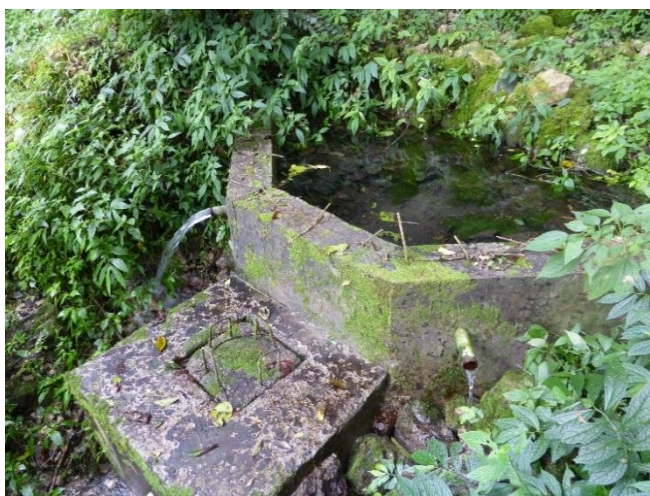
Figure 4 – Uaiquirona Spring intake

The intake has been constructed very close/over the spring, which results in some water soaking directly into the ground. In the dry season, the spring continues to flow (though less) but the supply of water to the lower end of the system is minimal. WaterAid believes this is due to leakage and users at the top of the system removing water directly from the pipe.

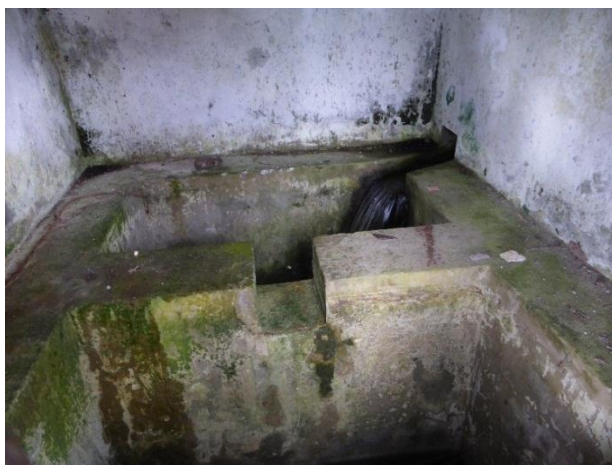
Figure 5 – Uaibua Spring intake

Originally the water system connected more or less directly from the spring to the Old Portuguese tank and then to the clinic. The system was rehabilitated by a government-employed contractor in 2011, including the construction of a large water tank in the rear of the police station, another in the rear of the clinic and a series of public tap stands along the east side of the main road. After approximately one year this water supply failed (reportedly due to informal connections) and since then users from the police station and downstream have had to fetch water elsewhere.

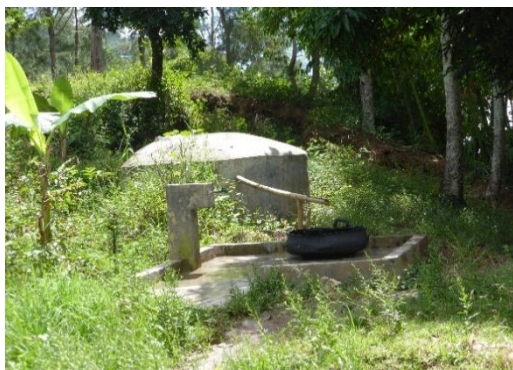
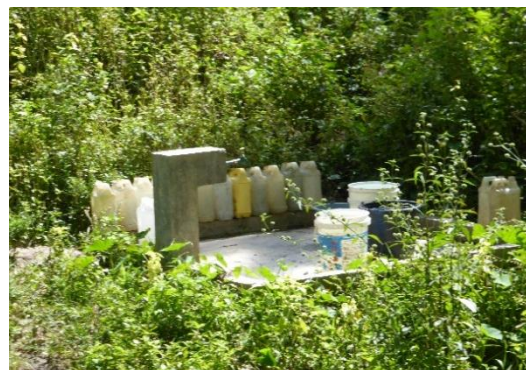
Figure 6 – Examples of public tap stands in the Uaibua system along the main Ossu road

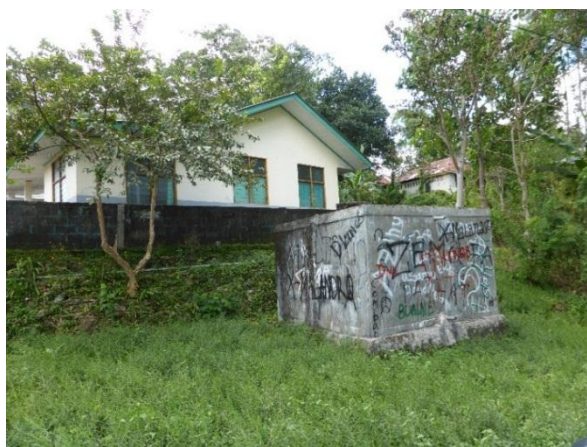
Figure 7 – Uaibua system tank in front of the Ossu clinic (tank is usually dry but leaked in the past)

The existing GI system has many informal connections and leakage points, which require rehabilitation. Works would also include rehabilitation or replacement of tanks (e.g. the tank at the clinic is not watertight) and rehabilitation of existing distribution lines and tap stands so community can access water without cutting the pipe.

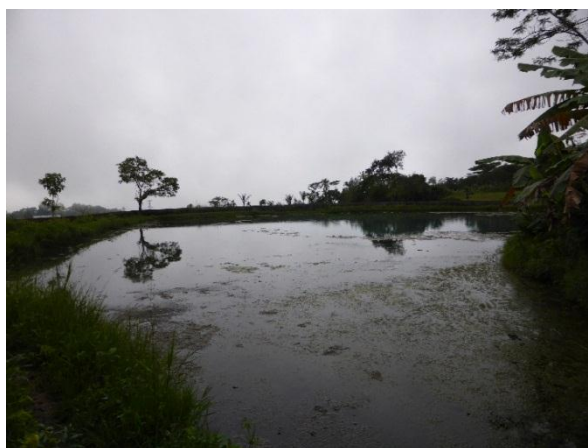
The Weulau spring is a significant water source situated downhill of the main Ossu township. It provides water supply to two aldeias (hamlets) of approximately 200 households (1200 residents) in the southern part of Ossu. It is also an important water source for rice field irrigation south of Ossu and supplies vegetable and livestock farms.

Figure 8 – Weulau upwelling

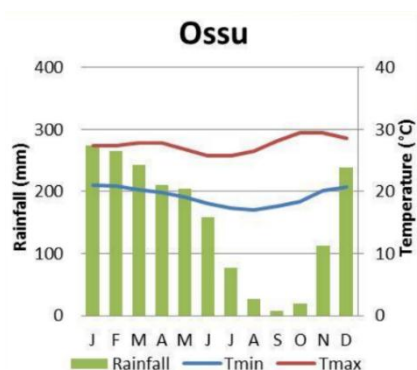
Ossu's annual rainfall is approximately 2000 mm, with the distribution shown in Figure 9. There is significant potential for harvest of rainwater, especially in institutions such as schools, though for the three months of the dry season this supply would be unreliable. WaterAid recommends that the use of rainwater should be limited to non-potable uses (toilet flushing, hand washing, clothes washing, garden watering etc.). As in many Timorese communities, there is social stigma associated with drinking rainwater; during the community meeting one community leader noted that while the community 'make the most of the rainfall in the wet season', it is linked with rheumatism, arthritis and increases in tuberculosis cases.

Figure 9 – Average annual rainfall for Ossu<sup>7</sup>

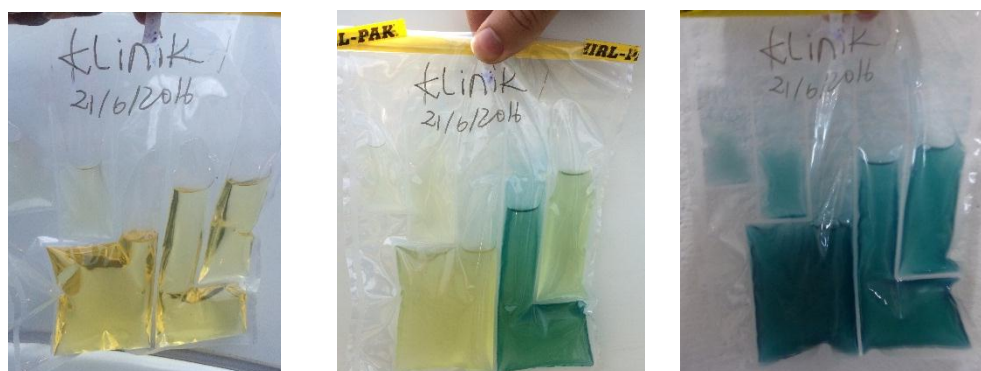
System	Test location	MPN*/100ml	Health Risk Category
Uaiquirona	Tank 3 (Olokasa)	>100	Unsafe
Uaibua	Uaibua spring	>100	Unsafe
Loidiqui	SCMM tap	48.3	High Risk/Possibly unsafe
Weulau	Weulau spring	>100	Unsafe
Clinic Tank	Patient toilet tap	>100	Unsafe

Figure 10 – Example of the water quality test results from the clinic – original test (left), preliminary result shown to community after two days (centre) and fully developed result after four three days (right). Blue colour indicates presence of bacteria

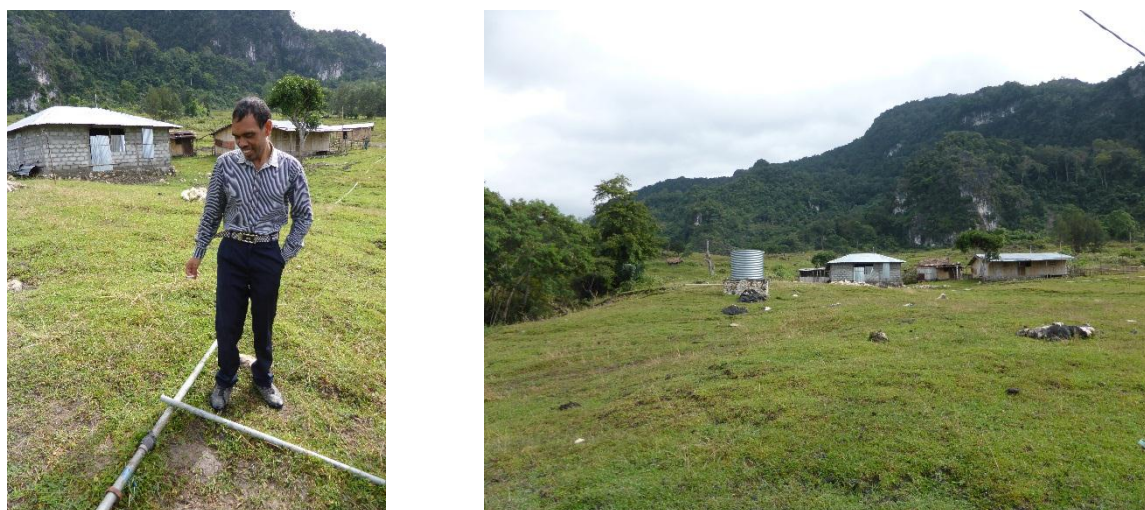
Figure 11 – Olokasa tank and disconnected tee

During the dry season this system runs dry. When the school does not have water the students collect it from the Uaibua spring.

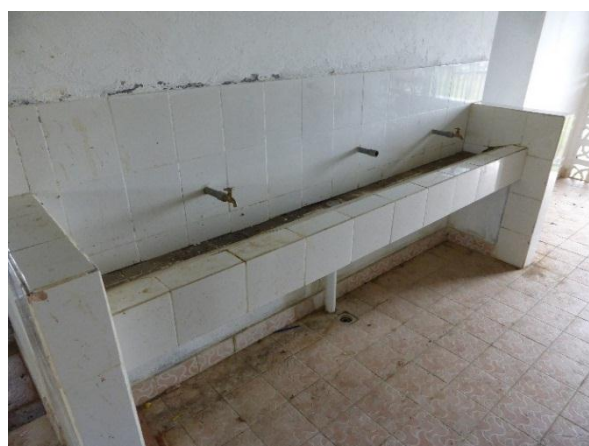
The student council is currently responsible for cleaning toilets and fetching water, which is scheduled for Saturdays. However WaterAid's observation was that no technical maintenance is being done. The hand washing facilities are unused as there is no water.

Figure 12 – Olokasa school hand washing facility

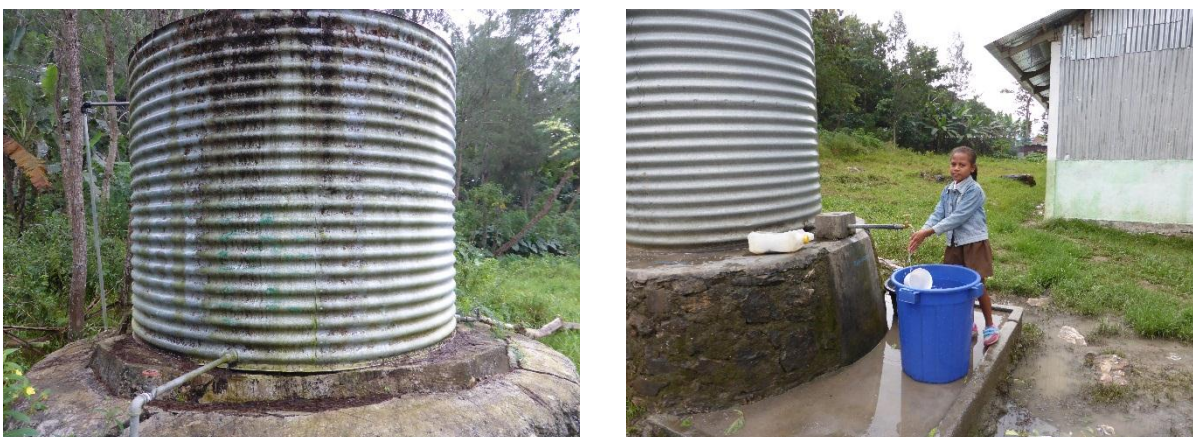
The first water tank supplying the upper toilet block has rusted through the base and is no longer holding water.

The third tank supplying the lower toilets block does not connect to the toilets.

Figure 13 – EBC Mundo Perdido tanks – rusted upper toilet block tank (left) and kitchen tank (right)

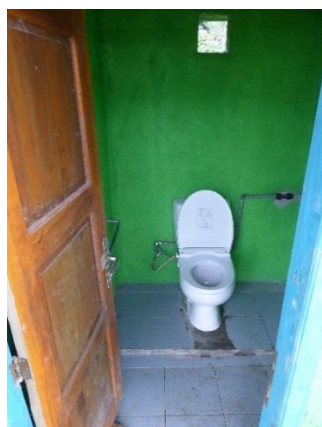
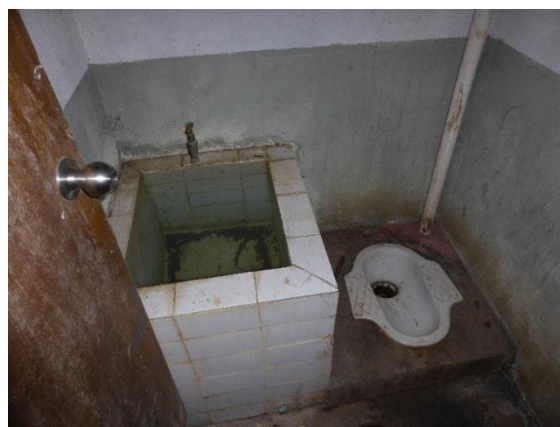
Figure 14 – EBC Mundo Perdido toilets – disability accessible (left) and lower toilet block (right)

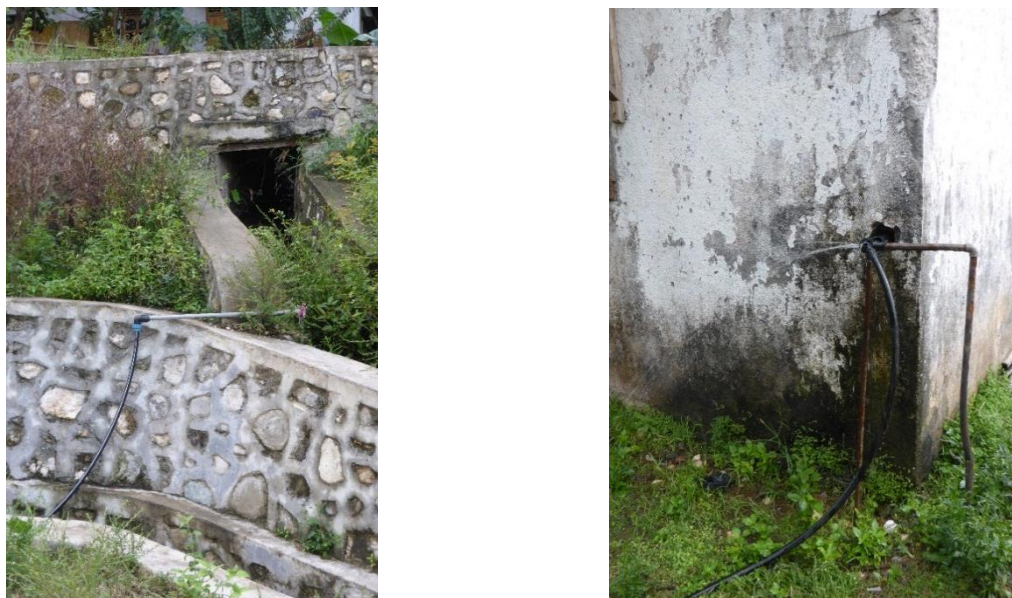
As with all Ossu Parish facilities, the junior high school accesses water from the Loidiqui spring, constructed in 1992. The tapping for the school is a poorly-connected hose which leaks badly.

The connection to the school bathrooms is held together by tape and leaks extensively. It is doubtful much water is supplied to the bathroom facilities. This pipe is also often disconnected by neighbouring households to collect water.

Figure 15 – St. Terezinha Junior High School connection to Loidiqui system (left) and bathroom connection (right)

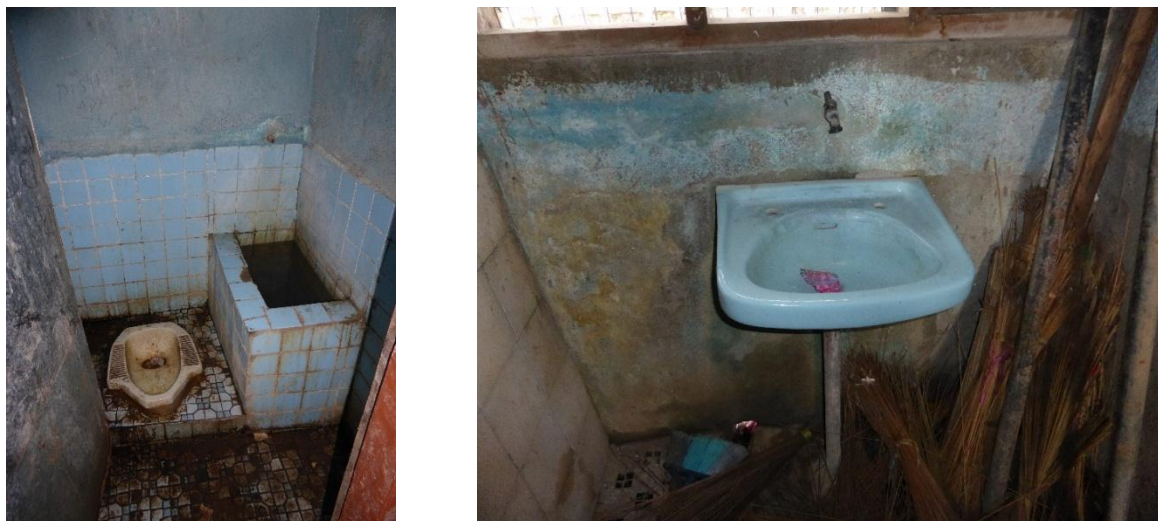
Only three of the five toilets are functioning, though all are currently used. Male and female students and teachers use the same facilities. Cleaning of the toilets is done by student council members on Saturdays. The one hand washing basin had no functioning water supply (disconnected). No soap was observed.

Figure 16 – St. Terezinha Junior High toilet and hand washing basin

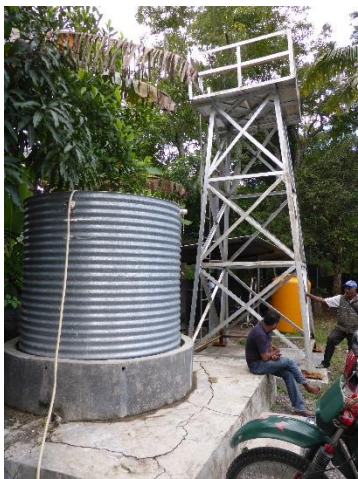
The clinic has a 3000 L tank and a 1500 L tank on site. The original plan was to place the 1500L poly tank on the existing tank stand, however due to the current arrangement of trucking water in (and the difficulty in pumping from the truck to the raised tank), this has been delayed.

Figure 17 – Clinic water tanks

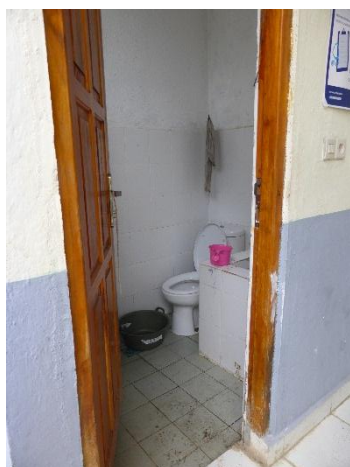
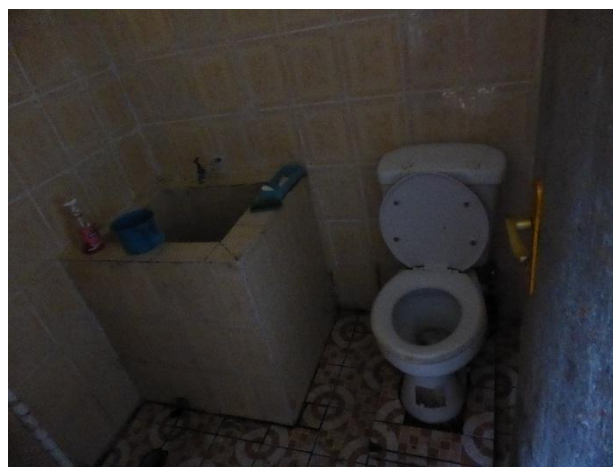
Figure 18 – Clinic toilets – patient toilet (left) and staff toilet (right)

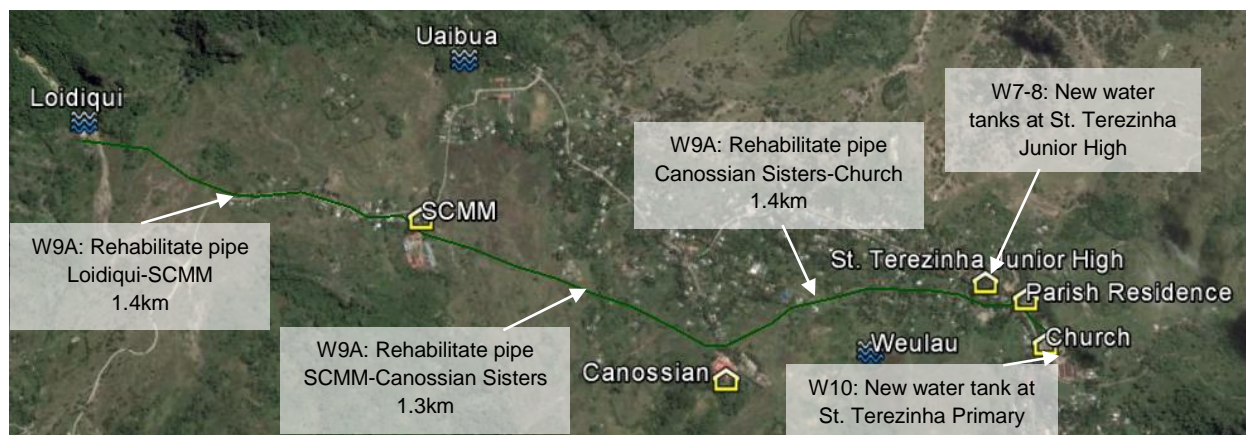
Figure 23 – Rehabilitation of Loidiqui system

The existing GI system has many informal connections and leakage points, which require rehabilitation. Works should also include construction of additional tanks near SCMM and Canossian Sisters and provision of distribution lines to tap stands so community can access water without cutting the pipe. Comments made by Fr. Evaristo in the community meeting indicated willingness to provide distribution points for the community along the system.

Formation of a management group is recommended, including training for maintenance and system operation. However consideration should also be given to the existing maintenance regime by the church. Close collaboration with the Parish will be central to any works on this system.

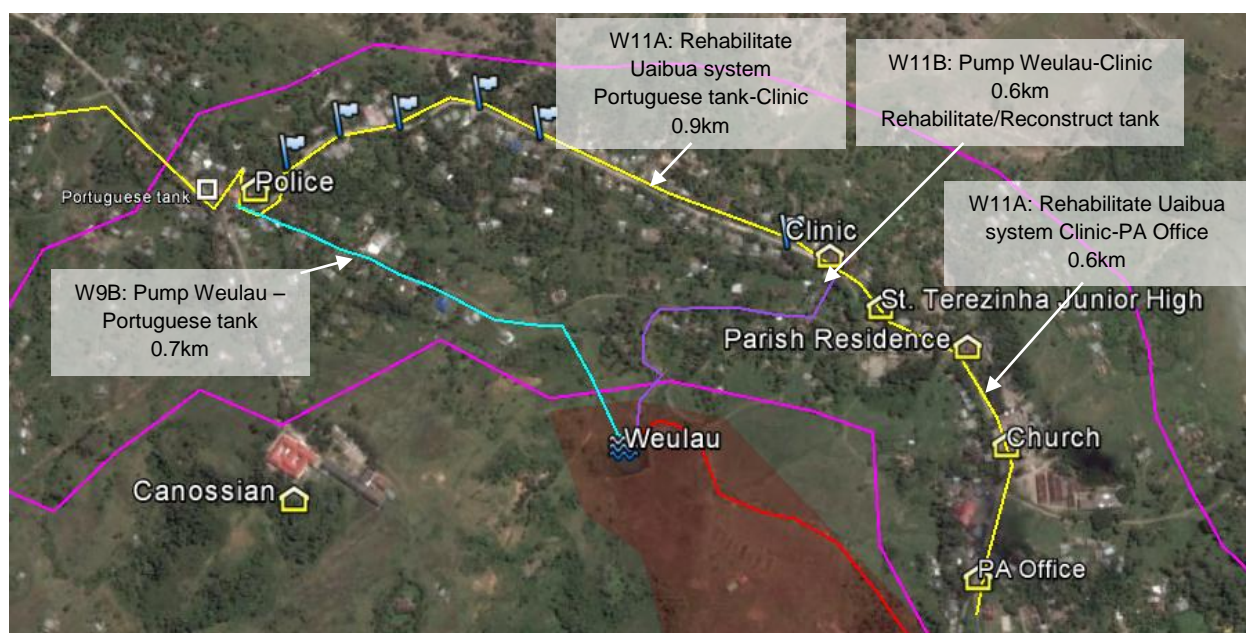
Figure 24 – Weulau System Options

WaterAid identified three options for construction of such a system, summarised in Table 5.

Based on the above considerations, WaterAid believes Option 1 to be unfeasible, and Options 2 and 3 are both technically and socially complicated. However, given appropriate community involvement, Municipal DAA involvement, clear system management structures, and deterrence from community interference in the pressure pipe, Option 2 (refer recommendation W9B) or Option 3 (refer recommendation W11B) could be achieved.

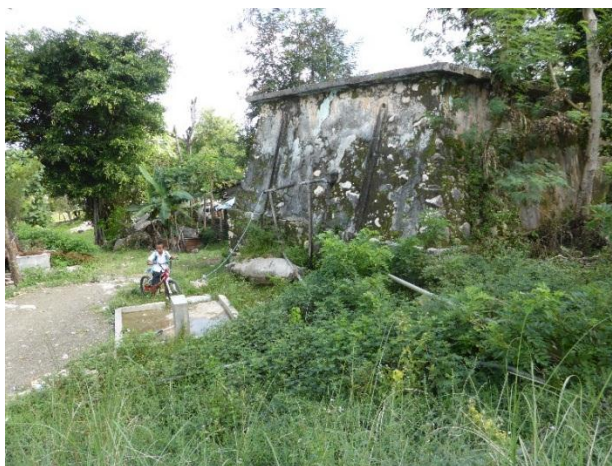
Figure 25 – Old Portuguese tank opposite PNTL office
